# **Appendix A**

## **Site Photographs**

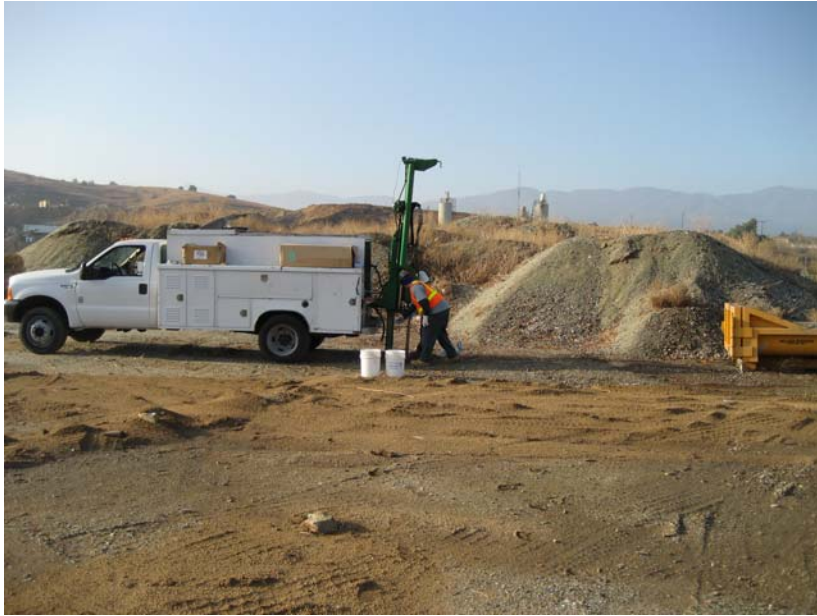
BC2 Drilling using GeoProbe collecting samples at CC-047-02, near glass pile on 2-21-07.  
Photo by B. Castellana.

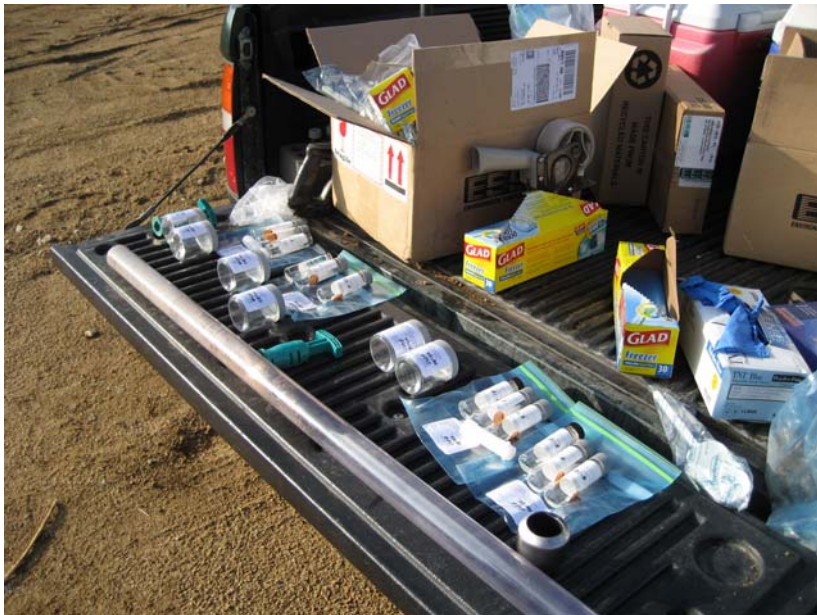
Sample in dedicated acetate liner; the surface is to the right and the 2-foot depth is to the left in the photo. Photo by B. Castellana.

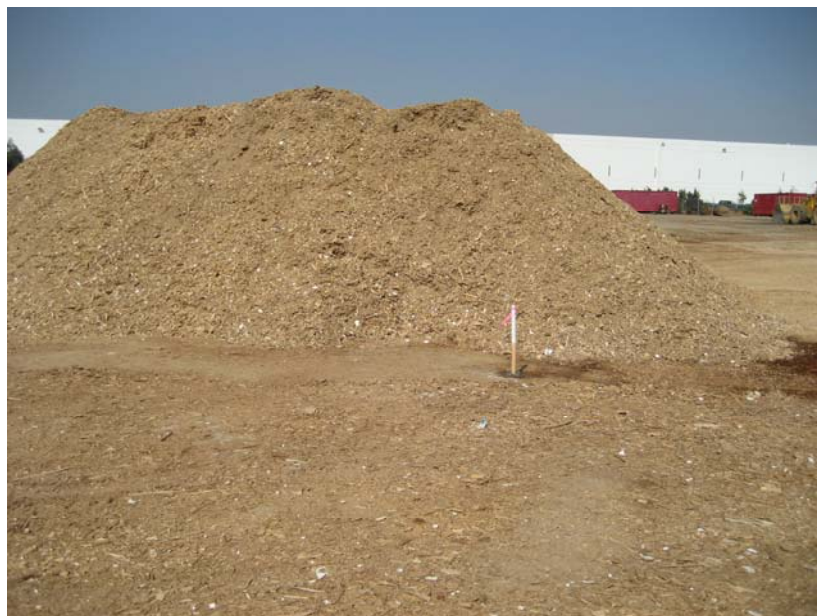
Sample location CC-048-01 near woodpile, taken from east. Photo by B. Castellana.

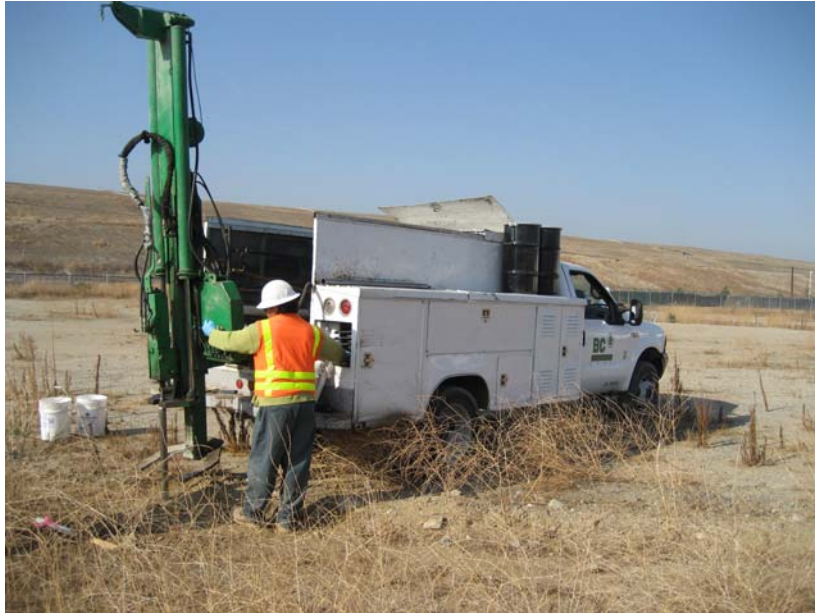
Collecting sample at location CC-048-04. Photo by B. Castellana.

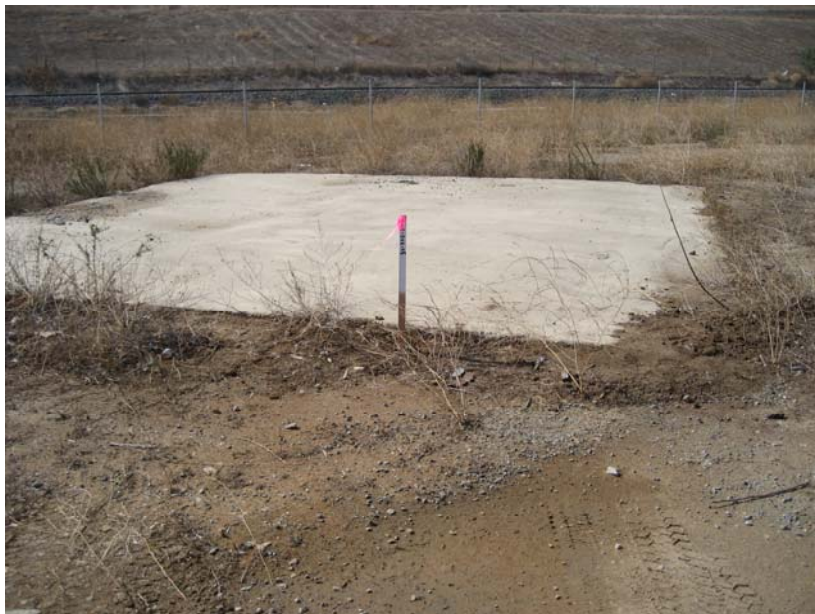
Sample location CC-048-05 adjacent to concrete pad from north. Photo by B. Castellana.

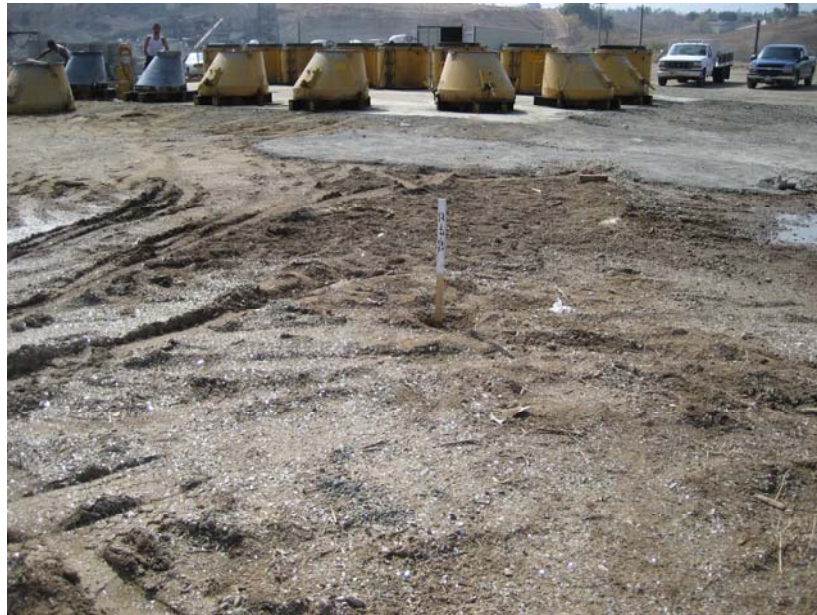
Sample location CC-047-02 near concrete pad, taken from north. Manhole Builders is shown behind the sampling location. Photo by B. Castellana.

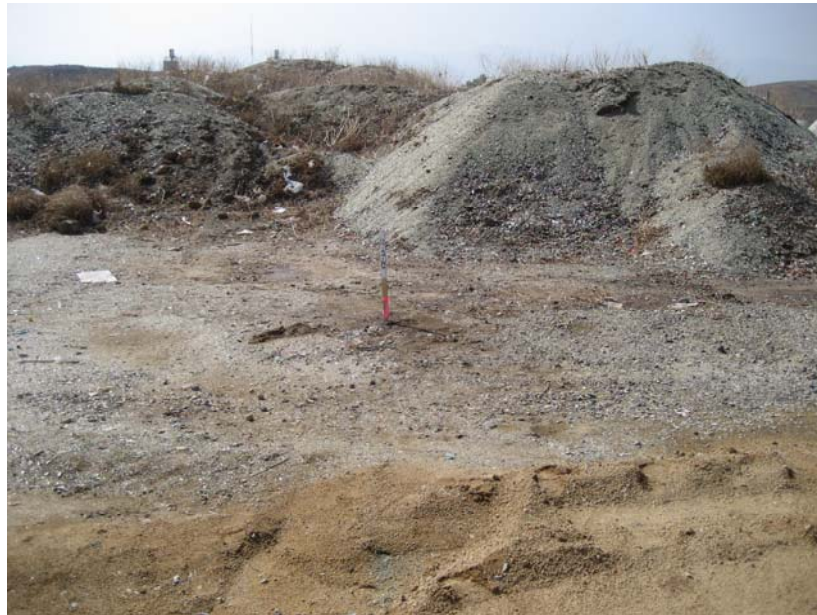
Sample location CC-047-03 near finely shredded glass pile, taken from north. Photo by B. Castellana.

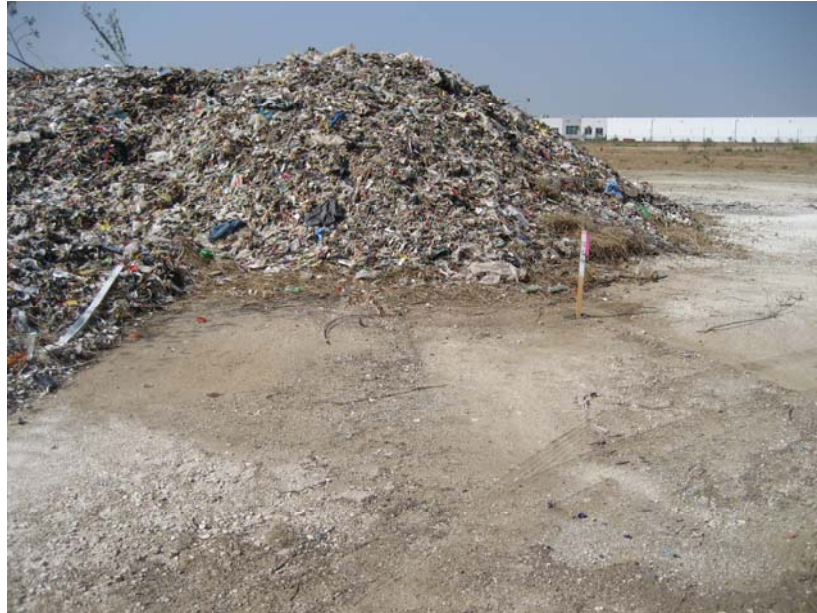
Sample location CC-047-03 near debris/glass pile, taken from northeast. The white material, which shows up in the aerial photos used in planning for this investigation, is loose pumice, which is not native to the area. Photo by B. Castellana.

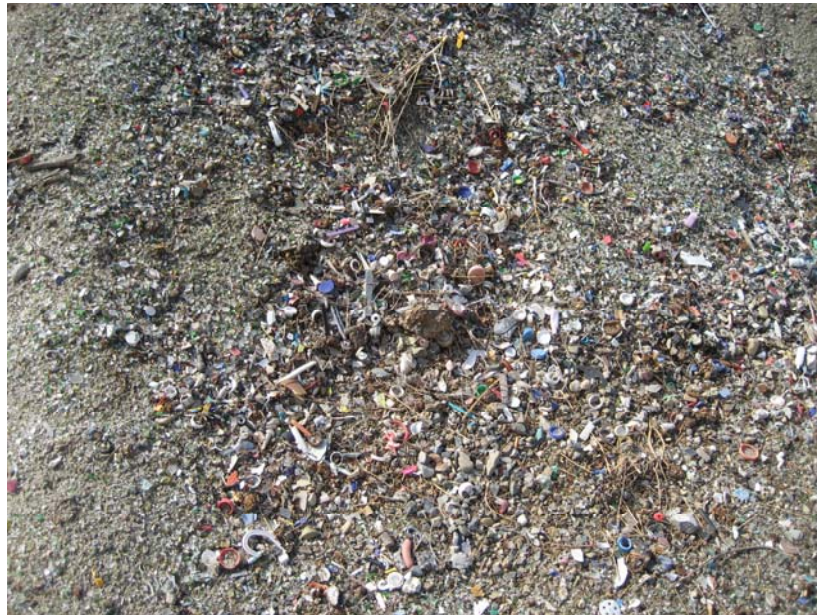
Closeup of the contents of the pile near location CC-047-03; the debris is predominantly sand- to pea-gravel-sized shredded glass, taken from north. Photo by B. Castellana.

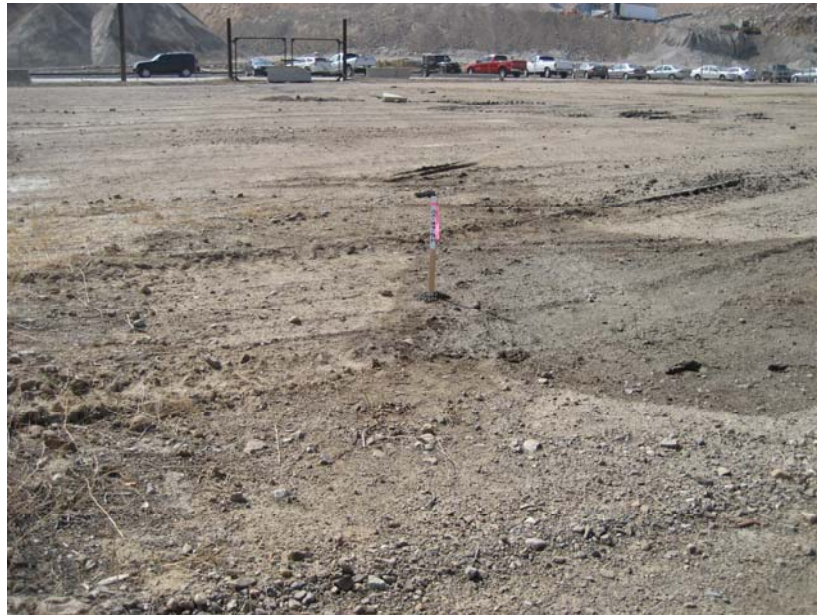
Sample location CC-037-02 in low spot in the central area of the field, taken from north. Photo by B. Castellana.

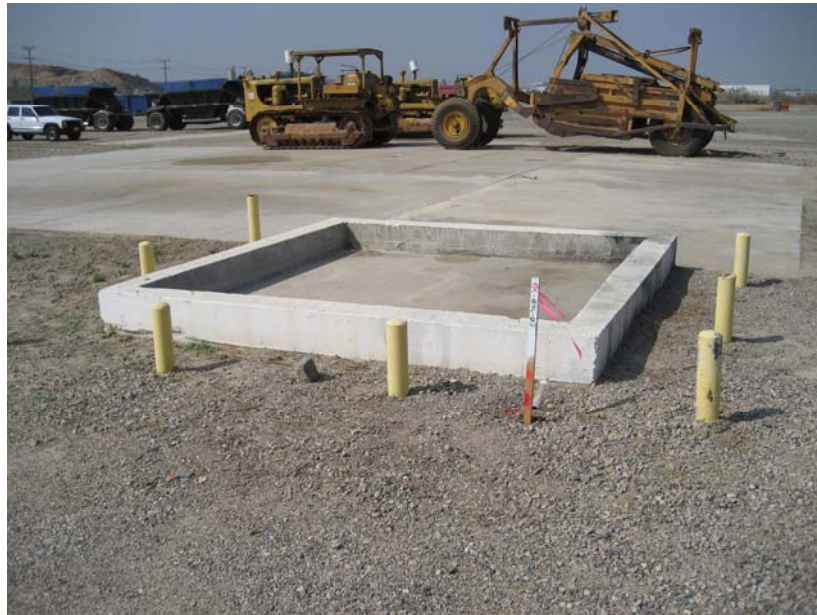
Sample location CC-046-03 adjacent to drainage pipe for what appears to be secondary containment for an AST, taken from the east. The surface sample collected contained the highest levels of TPH as diesel and motor oil. Photo by B. Castellana.

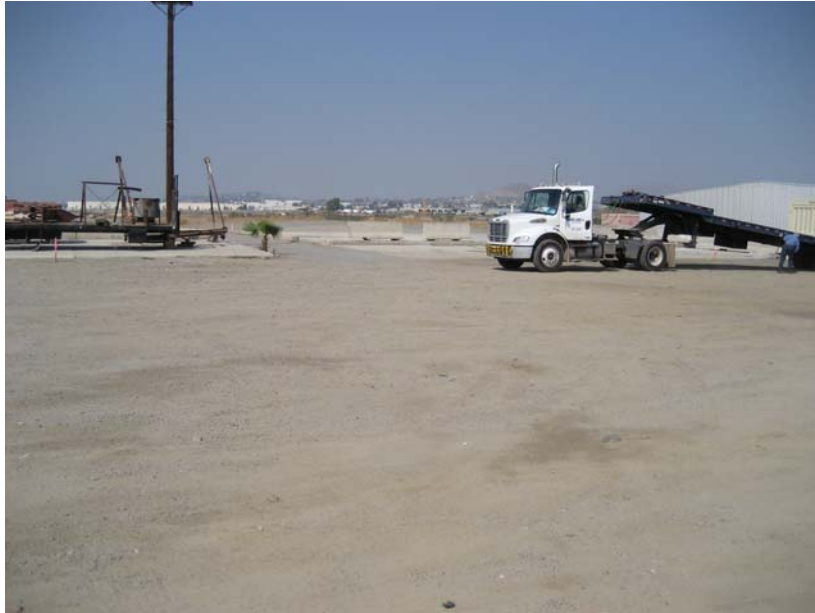
Sample locations CC-046-14 through -16 near the cleared pads in the northeast portion of the parcel. The surface sample CC-046-16 contained TPH as motor oil above the action level. Photo by B. Castellana.

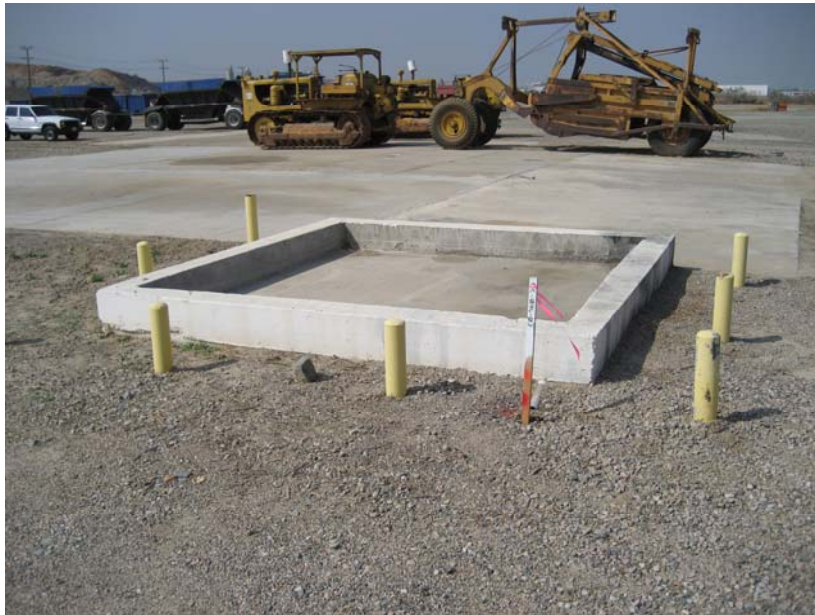
Sample location CC-046-03 adjacent to drainage pipe for what appears to be secondary containment for an AST, taken from the east. The surface sample collected contained the highest levels of TPH as diesel and motor oil. Photo by B. Castellana.

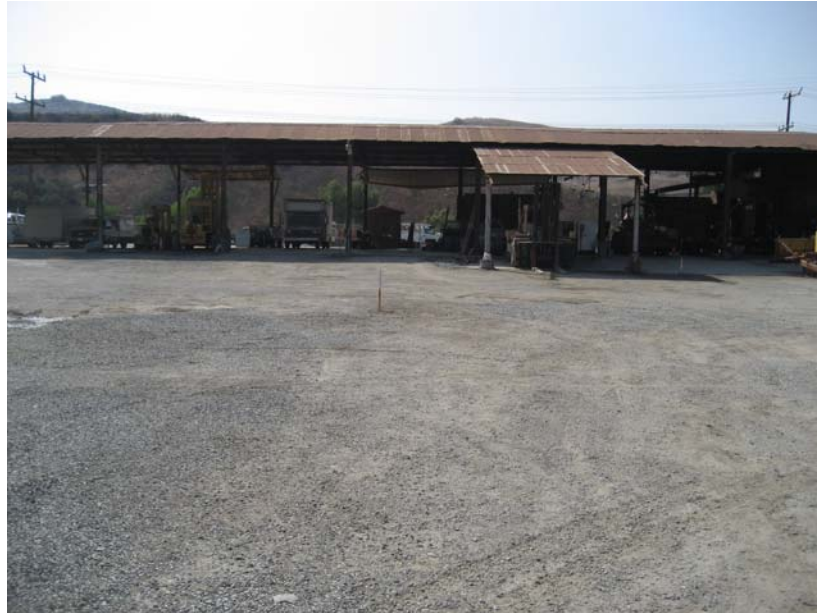
Sample location CC-046-07, -11, and -12 near the covered maintenance area in the southeast corner of the parcel. In addition, CC-046-19 is located behind the forklift in the left-hand side of the photo, which is taken from the north. Photo by B. Castellana.

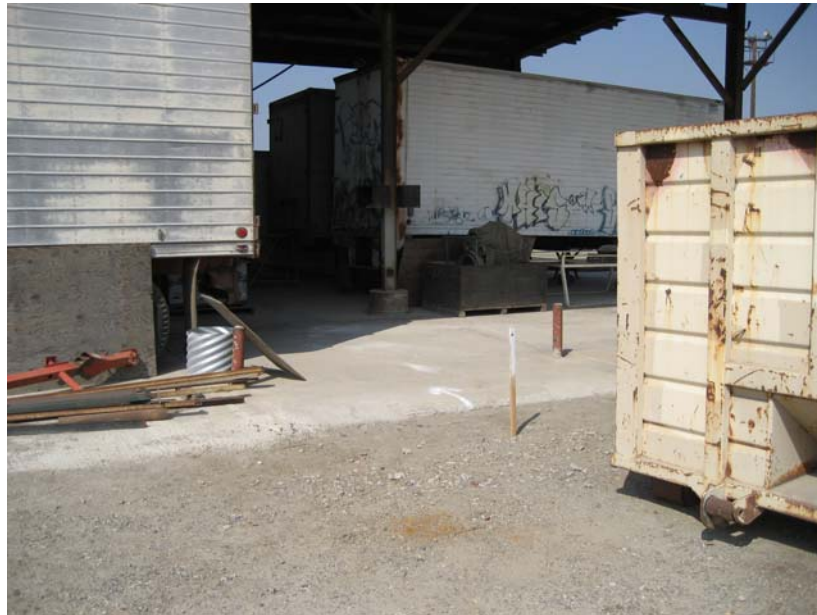
Sample location CC-046-04 in covered concrete pad area where trailers are staged. Photo by B. Castellana.

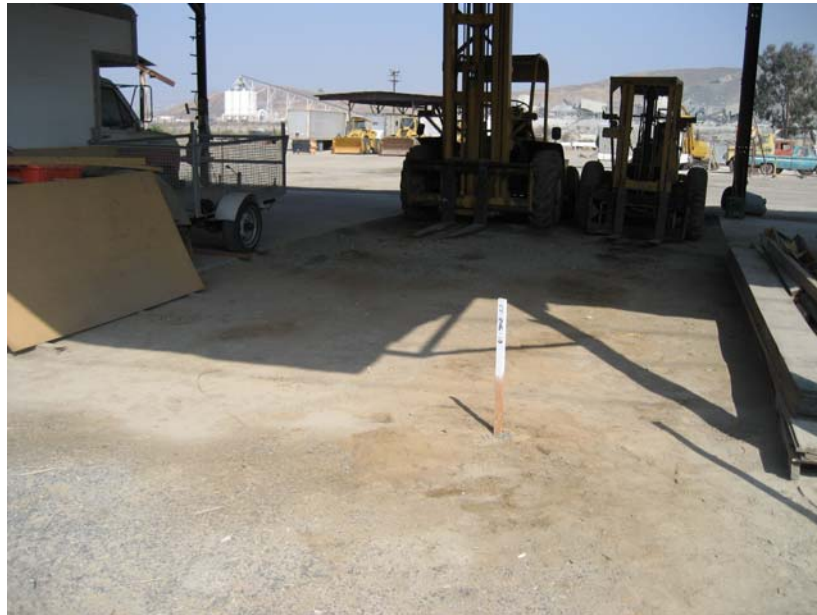
Sample location CC-046-19 in stained soils south of the maintenance pad. Photo is taken from the south. Photo by B. Castellana.

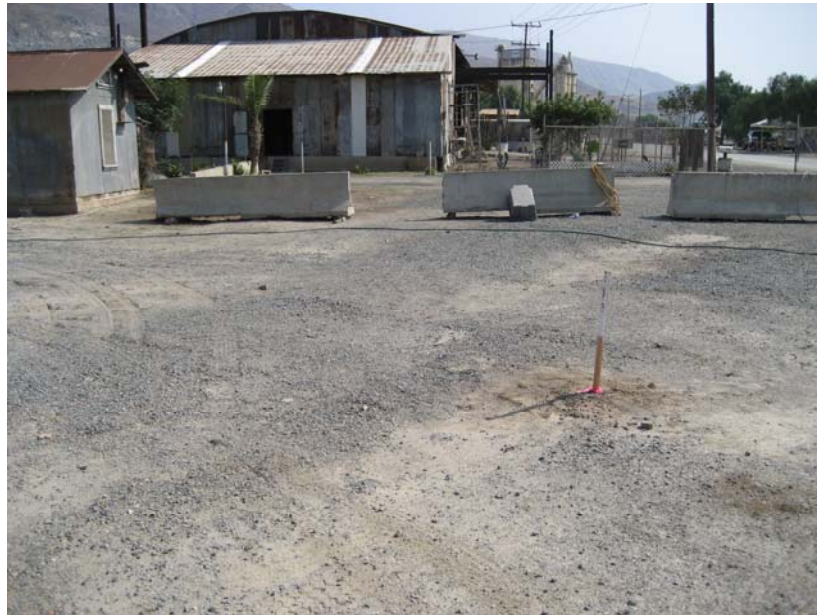
Sample location CC-046-05 in stained soils in parking area west of the maintenance yard; photo is taken from the west. TPH as diesel and motor oil was detected in the surface sample CC-046-05 above actions levels. Photo by B. Castellana.
